Report on the Investigation of the Collision  
Between M/V “Han Jin Gothenburg”  
and M/V “Chang Tong”

CASUALTY INVESTIGATION TEAM  
SHANDONG MARITIME SAFETY ADMINISTRATION  
OF PEOPLE’S REPUBLIC OF CHINA

27 December 2007

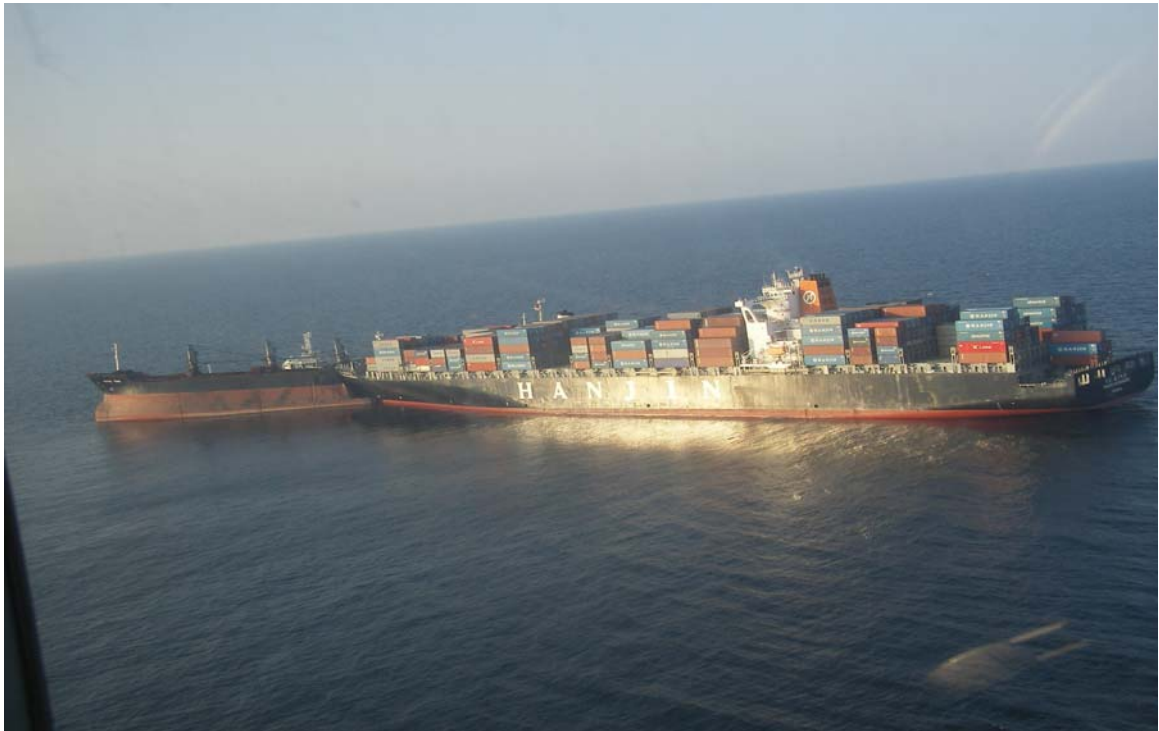
At around 1935hrs, position  $38^{\circ} 18.7'$  N,  $121^{\circ} 29.3'$  E, course  $091^{\circ}$  , speed 25.8kts, collision happened between vessel H and C with the ship's head of H collided the cargo hold 4-5 on port side of vessel C and collision angle is about  $40^{\circ}$  , the ship's head firmly inserted the body of vessel C and maintained firm occlude condition, H stopped her main engine urgently, kept inserting condition, pushed C moving forward, ship's speed decreased continuously, finally, they

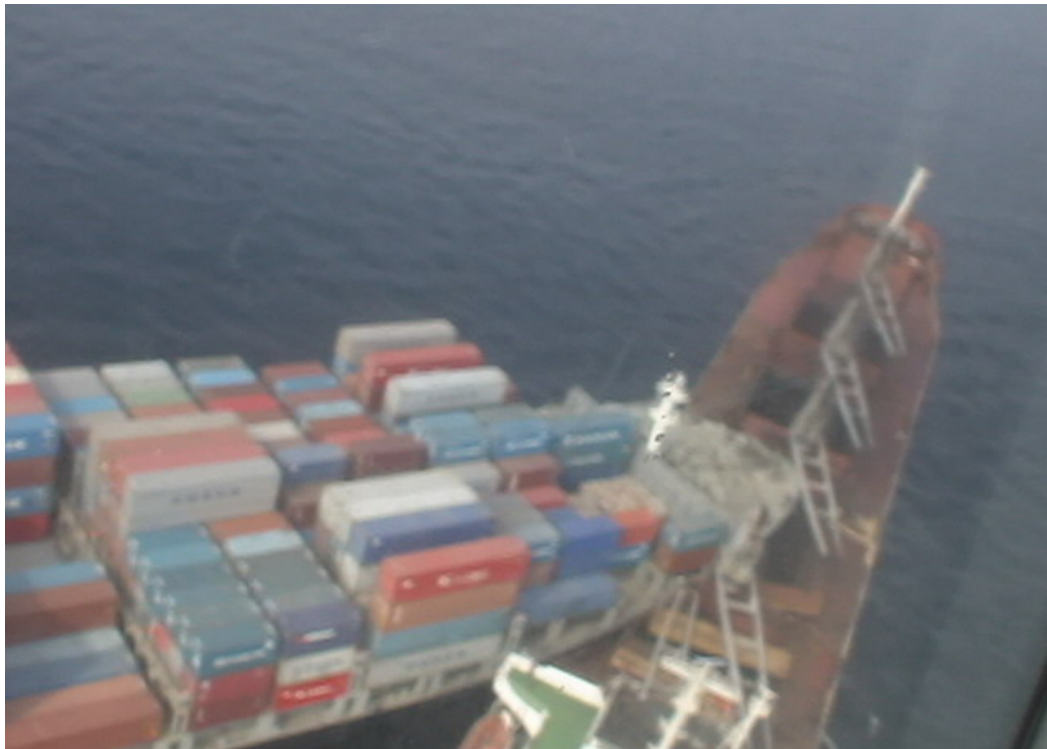
According to moving track displayed on AIS and external fact of occluded condition one another after collision, combining the statement of crew concerned, we determined that H collided C abaft her beam with a angle of  $40^{\circ}$  .
