MAIR050000200902

**Report on the Investigation of the Collision
between
Afflatus and Wen Yue
On 02 May 2009**

Shandong MSA

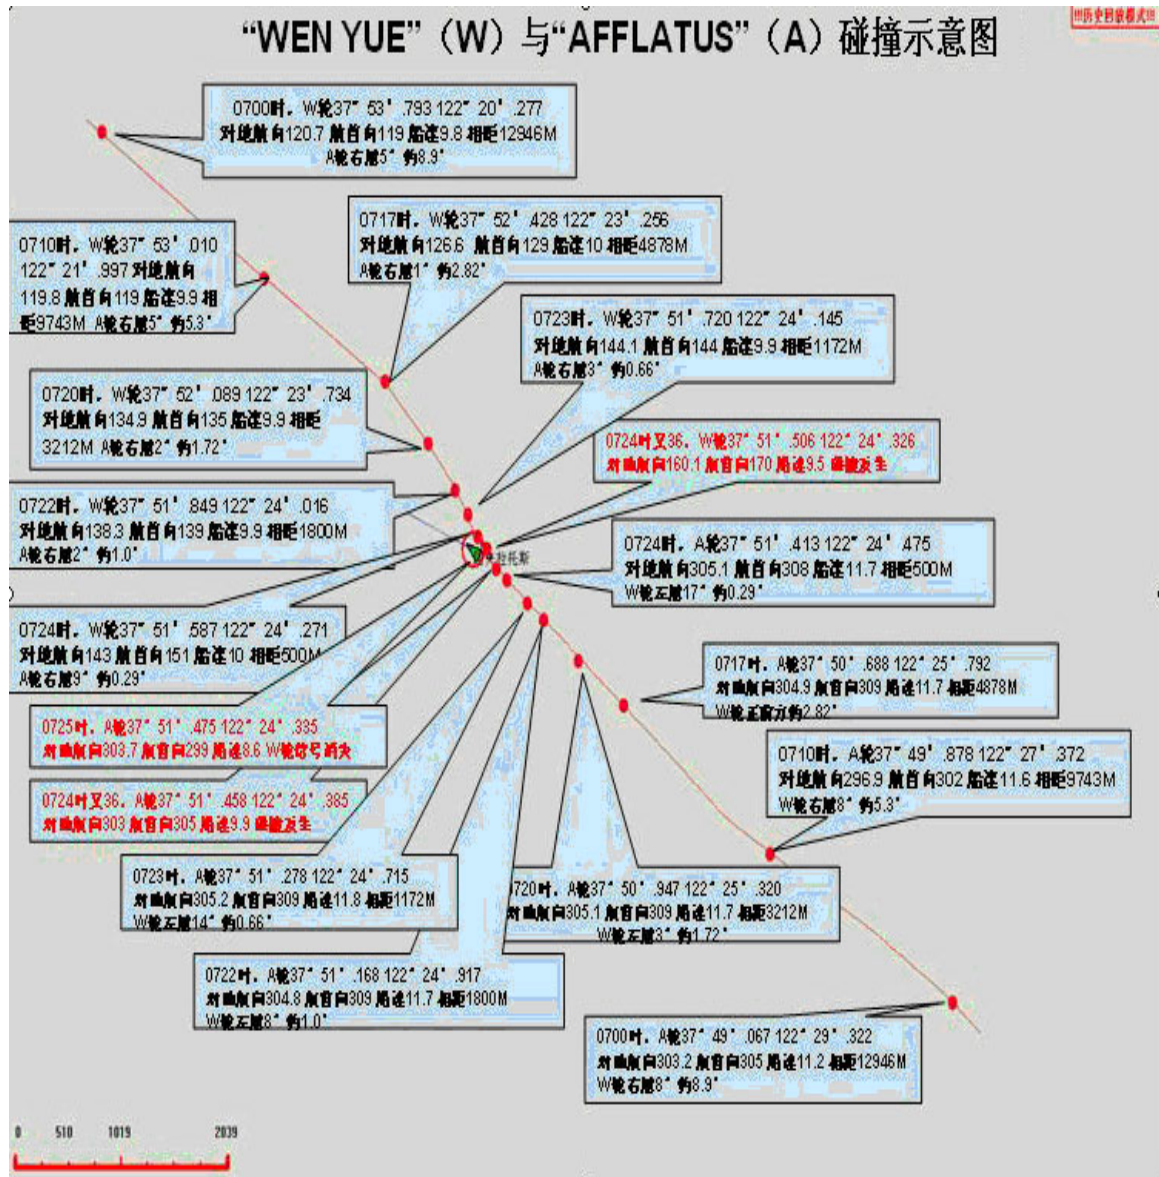
Diagram of collision

Data recorded by Vessel “A” AIS and VDR showed that the Vessel “A” heading was 305° and vessel “W” heading was 170° when the accident occurred. It was confirmed that vessel “W” had broken into two parts with about 22 meters length of the bow part by detecting under water.

As the result, two vessels collided with each other on almost 45° angle, the bulbous of “A” bumped into the port side bow of vessel “W” which caused vessel “W” crashed two parts and sunk immediately. Then vessel “A” navigated above that (refer to annex 6).

When the risk of collision exists between two ships, vessel “A” did not keep proper look-out, no discovering the ship in ahead, any action had not been taken to avoid collision. That were the direct causes of the close quarters situation forming and the collision accident happening.

When the DCPA was less than 0.5nm, vessel “W” had adopted of a series of small angle avoidance actions of turning right, not verify the measure effect until she was finally past and clear. That were the direct causes leading to the collision accident happened.
