Report on the Investigation of the Collision
between
Two High Speed Passenger Craft
New Ferry 85 and Dong Qu No.1
on 19 June 2006

Guangdong MSA

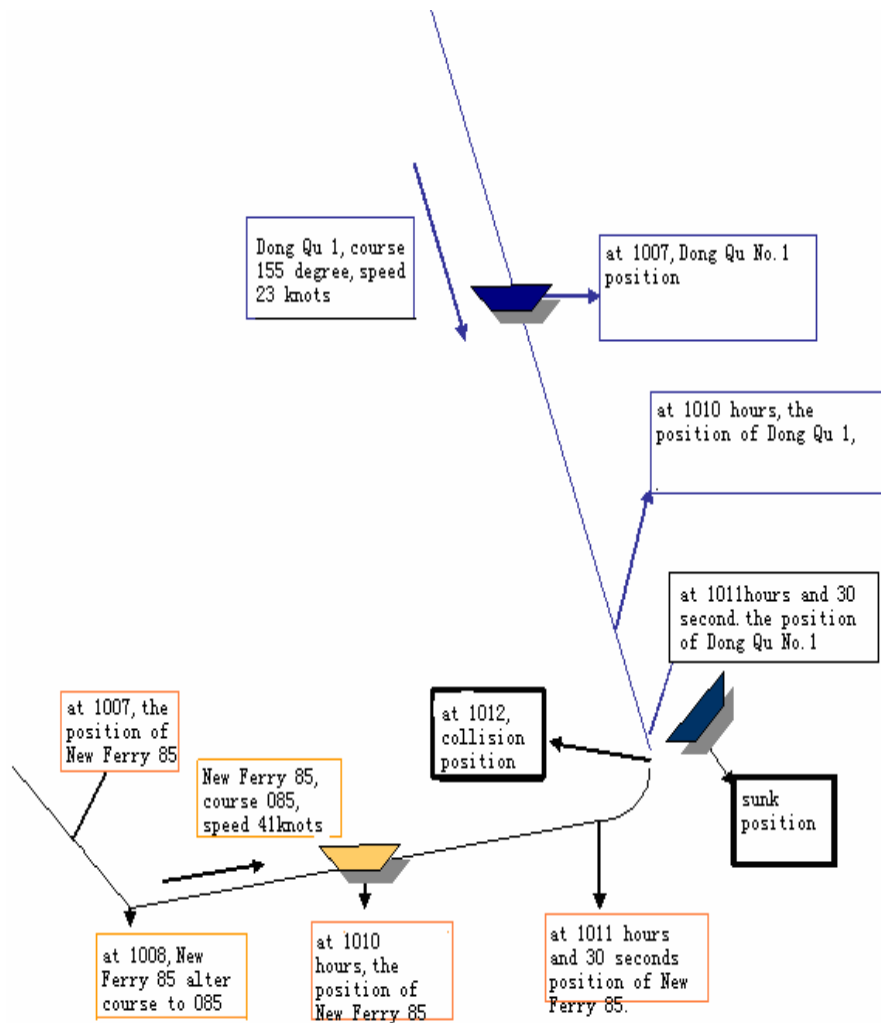
The sketch of collision between“Dong Qu No.1”and“New Ferry 85”

engine immediate with astern engine as to avoid collision. Finally the starboard bow of New Ferry 85 collided with the starboard quarter of Dong Qu No.1 in vertical direction.
