**Report on the Investigation of the Albany  
Sound Striking East Sea Bridge  
on 30 September 2004**

Shanghai MSA, China

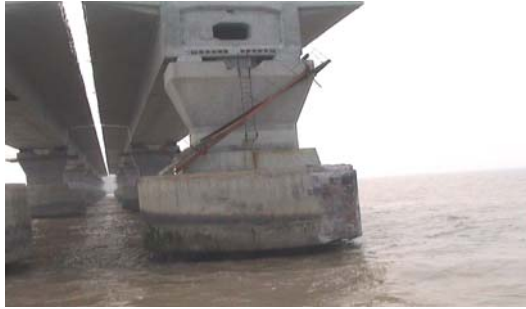
At about 1420, the second hatch of the starboard side collided with pier PM402-A, and then with pier PM401-B before her passing through the bridge. One minute later, the 2nd officer told the Capt. the accident and ordered standing by engine. When the Capt. came to the bridge, he ordered to check the damage to the vessel(seeing Pic. 2). When found there's no break on the vessel the Capt. ordered to go on sailing and reported the accident to Shanghai MSA at about 1610.

Picture 1 Damage to PM402-A    Picture 2 Damage to MV “ALBANY SOUND”

East Sea Bridge Construction and Management Company should settle to build the defense facilities.

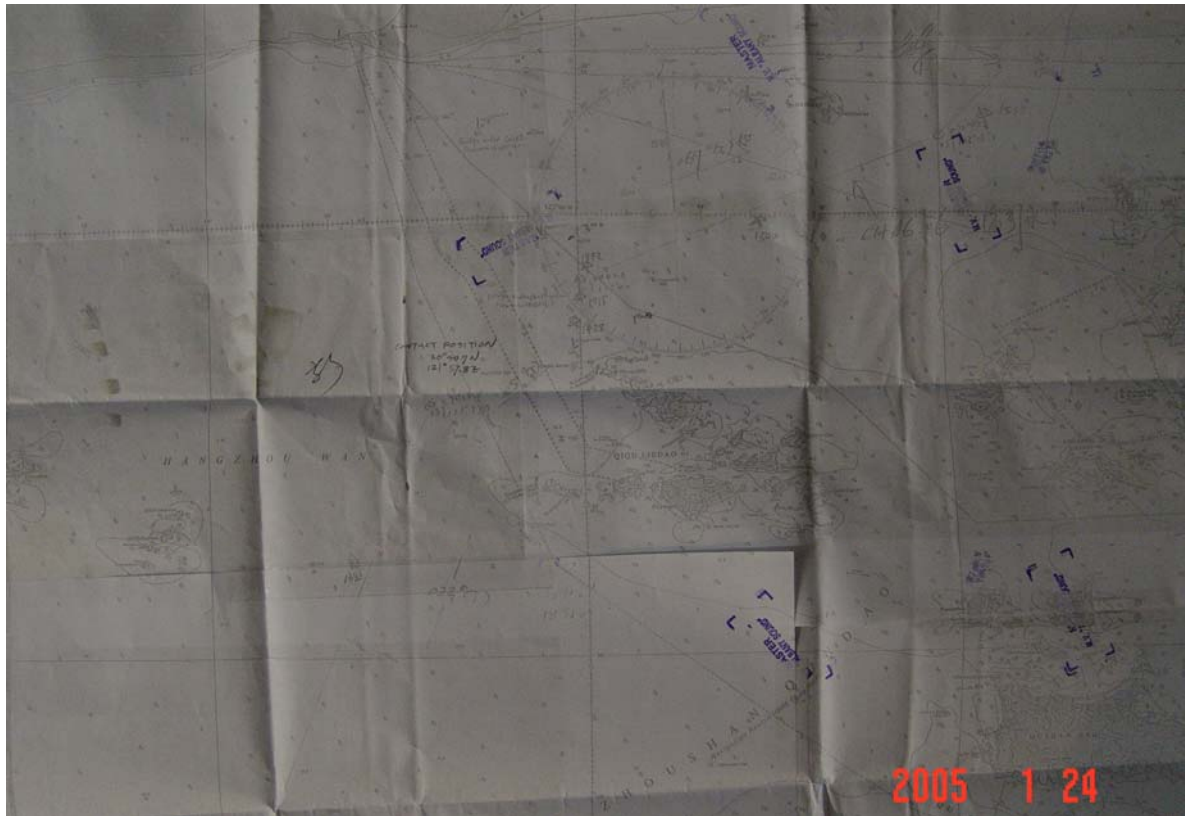
The investigators also found that the charts, MV “ALBANY SOUND” using, was admiralty charts, and the 2nd officer had not corrected them timely and completely(seeing Pic. 3).

Picture 3 the chart used by “ALBANY SOUND”

As very important navigational tools, the Capt. should prepare the proper charts and correct them in time according to the newest materials, including navigational notices, navigational warnings and notices to mariners, so as to make sure the safety of navigation. The authority should regard equipping with the proper chart and the correction of the charts as necessary check, and strength the checking of safety especially to those vessels with convenient flag.
