**Report on the Investigation of the Collision
between
BBC Ontario and Zhexiangyu 48038
on 1 October 2004**

Shanghai MSA, China
190# Siping Road, Shanghai, China
Tel.:+86-021-53931500

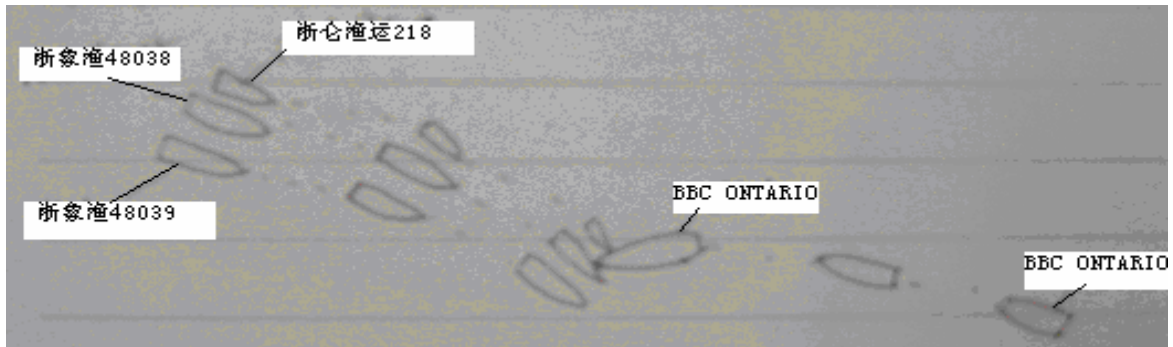
Picture 2: the Sketch Map of the Collision between the Two Vessels:

In the later time, "BBC ONTARIO" began to turn left to give way to "ZHEXIANGYU 48038" and to another two trawling boats. "BBC ONTARIO" was 140 meters away from "ZHEXIANGYU 48038", but to find "ZHEXIANGYU 48038" on the port side of herself when she was clear of the other two boats. "BBC ONTARIO" still turned left and the fishing boats turned right when there was only 70 meters between them. At about 0126, the two vessels collided with each other unavoidably.

At about 0126, “BBC ONTARIO” collided with “ZHELUNYUYUN 218” on the bow after the collision with “ZHEXIANGYU 48038”. After the collision, “ZHEXIANGYU 48038” sank at once, and all the 13 sailors on board the boat fell into the water and only 3 of them were rescued by “ZHELUNYUYUN 218” (Seeing Pic. 2).

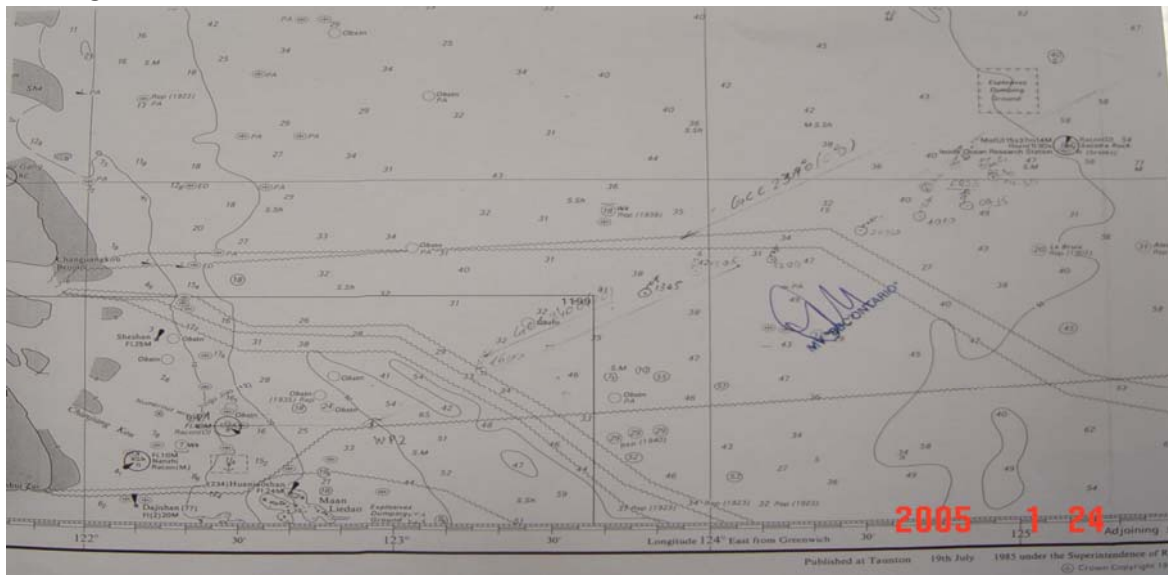
Picture 3 the sailing plan of “BBC ONTARIO”

At about 0925 on Sep. 30th in 2004, “BBC ONTARIO” left East Sea Shipyard in Shanghai for Massan port in Korea(Seeing the Pic. 3 above).
