MAIR050000200903

**Report on the Investigation of Collision  
between  
“CMB Biwa” and “Lu Ri Yu 1608”  
on May 5<sup>th</sup>, 2009**

Shandong MSA

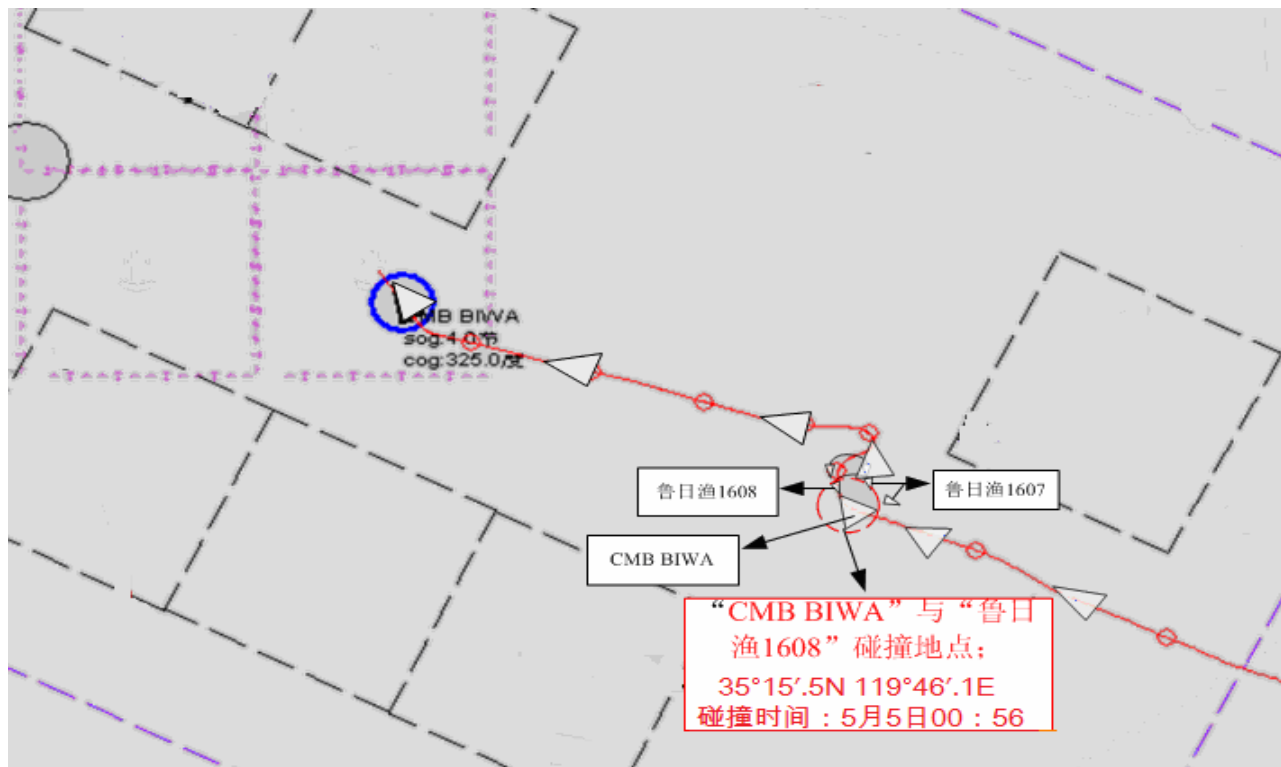
## 10.2 Diagram of collision

The starboard bow of BIWA collided with the starboard bow of fishing boat 1608, which is based on the following

The statement of the captain of BIWA and the duty officer shows that the bow of BIWA collided with the starboard at the bow of fishing boat 1608, followed by that the right anchor of BIWA scratched the front derrick of the fishing boat 1608, and the upturned fishing boat collided with the portside of BIWA.

The investigation on spot shows that the bridge of fishing boat 1608 was severely damaged and a four-meter long steel tube was left on the right anchor of BIWA.

Therefore, the report takes the angle of collision as between 30° to 55° (see file 9).
