**The Final Report on the Safety Investigation of
Air-conditioner Compressor Explosion on Board
Tanker Zhong Ran 53
off Jeju Island, Republic of Korea
21 May 2014**

Maritime Safety Administration of the People's Republic of China

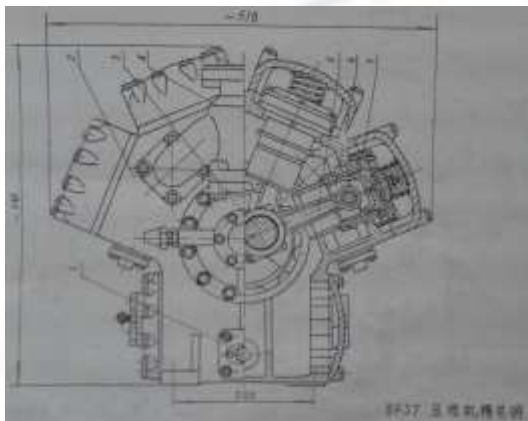
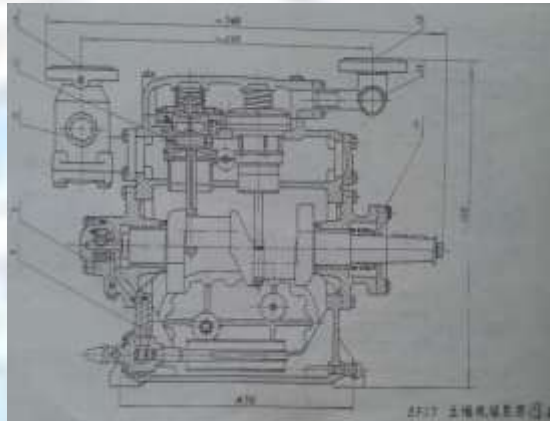
Figure 3: transverse view of the compressor Figure 4: compressor fore-and-aft view

3. The air-conditioner compressor was disintegrated, the fragments were projected outwards all around. Among the 4 compressing cylinder covers, only two were intact, one was totally shattered, the other one was with half left; the crankcase disintegrated completely; the 8 pistons and connecting rods are basically intact.

-
2. Due to oxygen enters into the refrigeration system, the compressor crankcase and cylinder were incapable of cooling, resulting in the continued rise of exhaust pressure and temperature. Eventually the temperature rises to oil mist ignition point, igniting the explosive gas mixture and causing explosion.

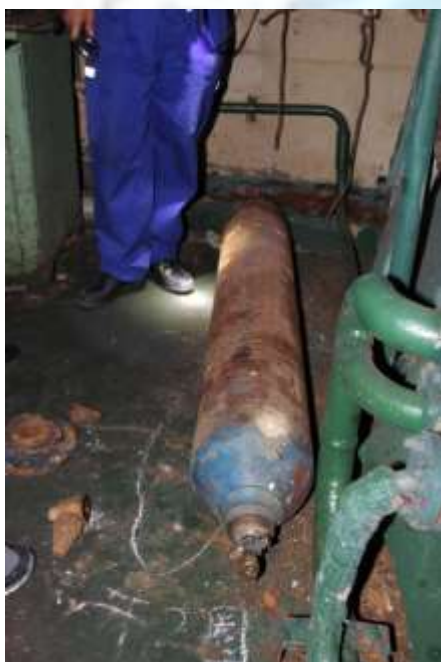
Figure 5: cylinder found at scene

4. A gas cylinder was lying down close to the refilling valve of air-conditioning system. The Surface of the gas cylinder is rusty and without any mark; its outlet valve is open, and the connecting pipe of bottle valve is ruptured. A damaged oxygen decompression meter is found at the scene, and no other gas cylinders were

1. According to the test report issued by Dalian Chemicals and Physicals Research Institute, the content from the cylinder at the explosion scene on board Zhong Ran 53 was oxygen, not Freon R22 or acetylene.
2. According to the proof of death issued by Korea S-JUNGANG hospital, the Second Engineer and Zhang's death was accidental. Zhang died of respiratory tract burning, The Second Engineer died of pulmonary edema from respiratory tract burning.

1. strictly implement SMS document requirements, especially requirements regarding crews sign on/off procedure, ship's material management and operational risks.
2. at once carry out a special operation to count, measure and log all materials on board ship, based on visual inspection of material itself to ensure consistency between paper record and real condition of materials, the log should indicate the storage place, put apparent labels on important items.

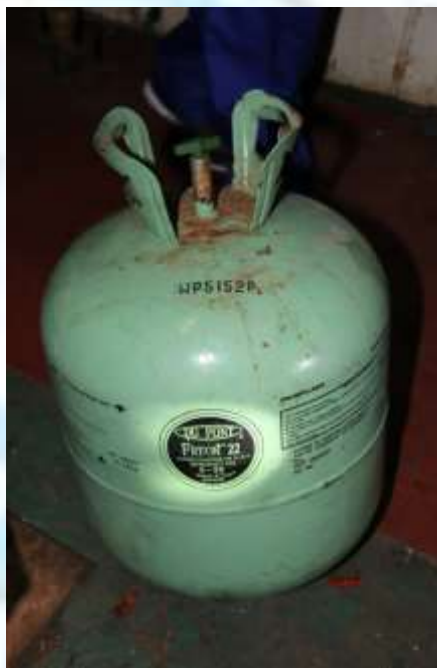
Figure 6: cylinder of R22

3. The ship and company's supply log records show there are 3 oxygen cylinders, 2 ethylene cylinder, and 1 R22 refrigerant cylinder (small). However the cylinder at the explosion scene was not recorded on the supply log.
4. According to Mr.Chen, the management staffmember of Zhongran Shipping, the refrigerants supplied by shore to ships are all in small sized R22 cylinders (net weight 22.7 KW); no big sized refrigerants cylinders were supplied.
