**The Final Report on the Safety Investigation of
Air-conditioner Compressor Explosion on Board
Tanker Zhong Ran 53
off Jeju Island, Republic of Korea
21 May 2014**

Maritime Safety Administration of the People's Republic of China

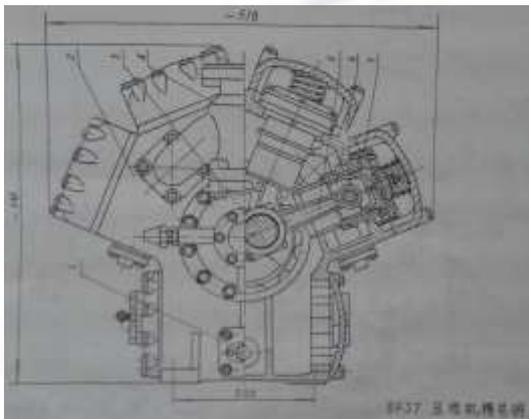
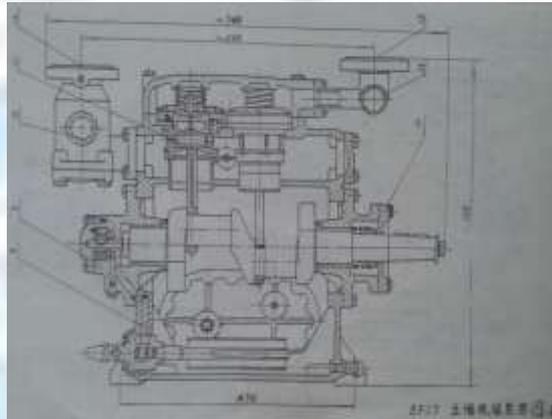
Figure 3: transverse view of the compressor Figure 4: compressor fore-and-aft view

3. The air-conditioner compressor was disintegrated, the fragments were projected outwards all around. Among the 4 compressing cylinder covers, only two were intact, one was totally shattered, the other one was with half left; the crankcase disintegrated completely; the 8 pistons and connecting rods are basically intact.

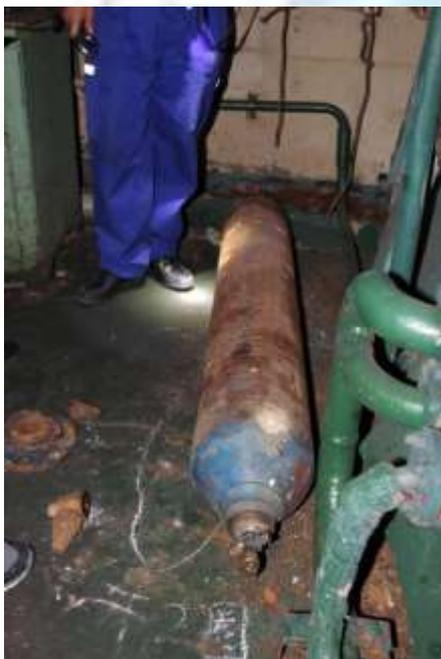
Figure 5: cylinder found at scene

4. A gas cylinder was lying down close to the refilling valve of air-conditioning system. The Surface of the gas cylinder is rusty and without any mark; its outlet valve is open, and the connecting pipe of bottle valve is ruptured. A damaged oxygen decompression meter is found at the scene, and no other gas cylinders were

1. According to the test report issued by Dalian Chemicals and Physicals Research Institute, the content from the cylinder at the explosion scene on board Zhong Ran 53 was oxygen, not Freon R22 or acetylene.
2. According to the proof of death issued by Korea S-JUNGANG hospital, the Second Engineer and Zhang's death was accidental. Zhang died of respiratory tract burning, The Second Engineer died of pulmonary edema from respiratory tract burning.

-
2. Based on the insufficient information exchanged from his predecessors, the Second Engineer believed there was large cylinder of refrigerants on ship, and subjectively presumed it was the cylinder inside the ice-room. Therefore he used this cylinder to refill air-condition system on two occasions.
 3. The Second Engineer and the Zhang-surnamed motorman lacked of safety awareness. They failed to assess and understand the safety risks of refilling operation, take precautions, even be warned after one refilling operation. Meanwhile, the lack of refrigerant refilling experience before let them fail to check safety procedure before operation.
 4. The absence of label on the cylinder objectively contributes to the wrong judgment of the Second Engineer.

1. strictly implement SMS document requirements, especially requirements regarding crews sign on/off procedure, ship's material management and operational risks.
2. at once carry out a special operation to count, measure and log all materials on board ship, based on visual inspection of material itself to ensure consistency between paper record and real condition of materials, the log should indicate the storage place, put apparent labels on important items.

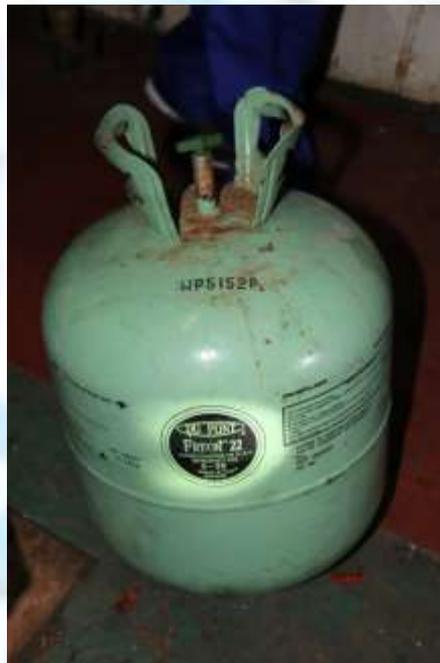
Figure 6: cylinder of R22

3. The ship and company's supply log records show there are 3 oxygen cylinders, 2 ethylene cylinder, and 1 R22 refrigerant cylinder (small). However the cylinder at the explosion scene was not recorded on the supply log.
4. According to Mr.Chen, the management staffmember of Zhongran Shipping, the refrigerants supplied by shore to ships are all in small sized R22 cylinders (net weight 22.7 KW); no big sized refrigerants cylinders were supplied.
