The Safety Investigation Report into the Crew Fatality  
onboard Dry Cargo Ship  
***M/V EN KAI***  
during Berthing Operation in Japan  
on 11 January, 2011

Maritime Safety Administration, P.R.China  
[www.msa.gov.cn](http://www.msa.gov.cn)  
August, 2011

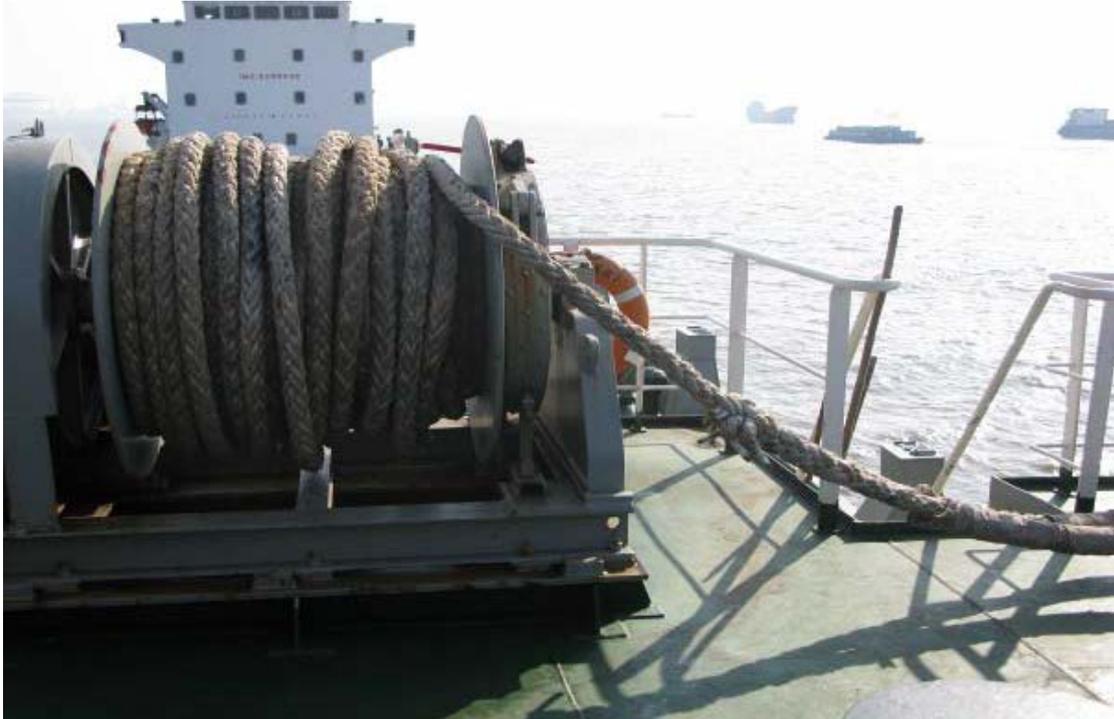
**Simulated Lay-out of the Head Spring of M/V EN KAI**

At 1005 hrs, the Master adjusted the vessel's position by engine astern. The bow was 7-8 meters from the jetty and the aft about 20 meters. When the bow mooring winch resumed work and the head spring fastened, the spring was directly rolled backward by the winch through the portside mooring hawse without going through the front guide pulley (details refer to the enclosure—Simulated Layout of Head Spring. The Master used hard starboard at dead slow ahead and the head spring was instantly tensioned and hitched on the steel plate corner of the mooring winch's base. Under the force of engine ahead, the tensioned spring slid out of the corner and bounced, knocked down the Bosun who was passing by the portside rail to return to the forecastle from the pump room.

According to the regulations of the Company's SMS documents on the instructions of mooring and departure, the C/O and 2/O should frequently report the situation of waters at bow and stern, the rope and the anchor to the Master. Although the rope had gone through the spring mooring hawse as in the normal way before the accident occurred, the rope eased off was not long enough and the spring was pulled out from the spring guiding pulley as the mooring winch was suddenly powered off. Under such circumstance, the C/O neither predicted the danger that the rope might bounce, nor reported the rope condition to the bridge, as the result of which the rope bounced up to the abnormal

working position under the sudden pull and knocked down the Bosun who was passing by that area.

During the process of berthing with line ashore, the bow winch was suddenly powered off and the rope therefore failed to be released in a timely manner and had to be pulled off the spring from guide pulley manually. When the Bosun went down to the power room to restart the power and returned to the forecastle by the ladder of the inboard side, the rope bounced out and knocked him down.
