The safety investigation report into the Grounding
Accident of

MV Shen Neng 1

on Douglas Shoal, Queensland
on 3 April 2010

Maritime Safety Administration, P.R.China

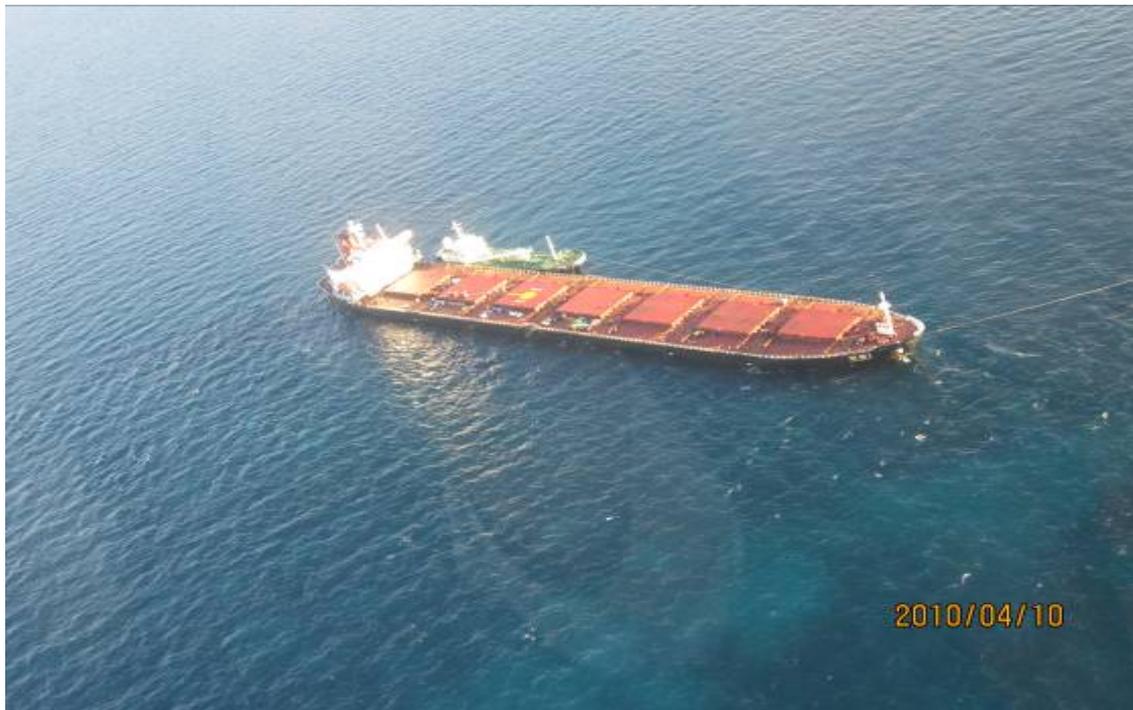
At about 1705 on 3rd April 2010, the China registered bulk carrier *ShenNeng 1* grounded on the Entry Prohibited Area of the Great Barrier Reef Marine Park, Douglas Shoal, Queensland (AP 23°06'S/ 151°39.6'E). The ship was owned by Shenzhen Energy Transport, and managed by Tosco Keymax International Ship Management Company. At the time of the accident, the ship was loaded with a cargo of about 68,052 tons of coal and departed for Bayuquan port of China. The ship's bottom was damaged with a small amount of fuel oil leakage. Some amount of coral reef was damaged without casualty, and the direct economic loss is unspecified.

Figure 1: *ShenNeng 1* agrounded on Douglas Shoal

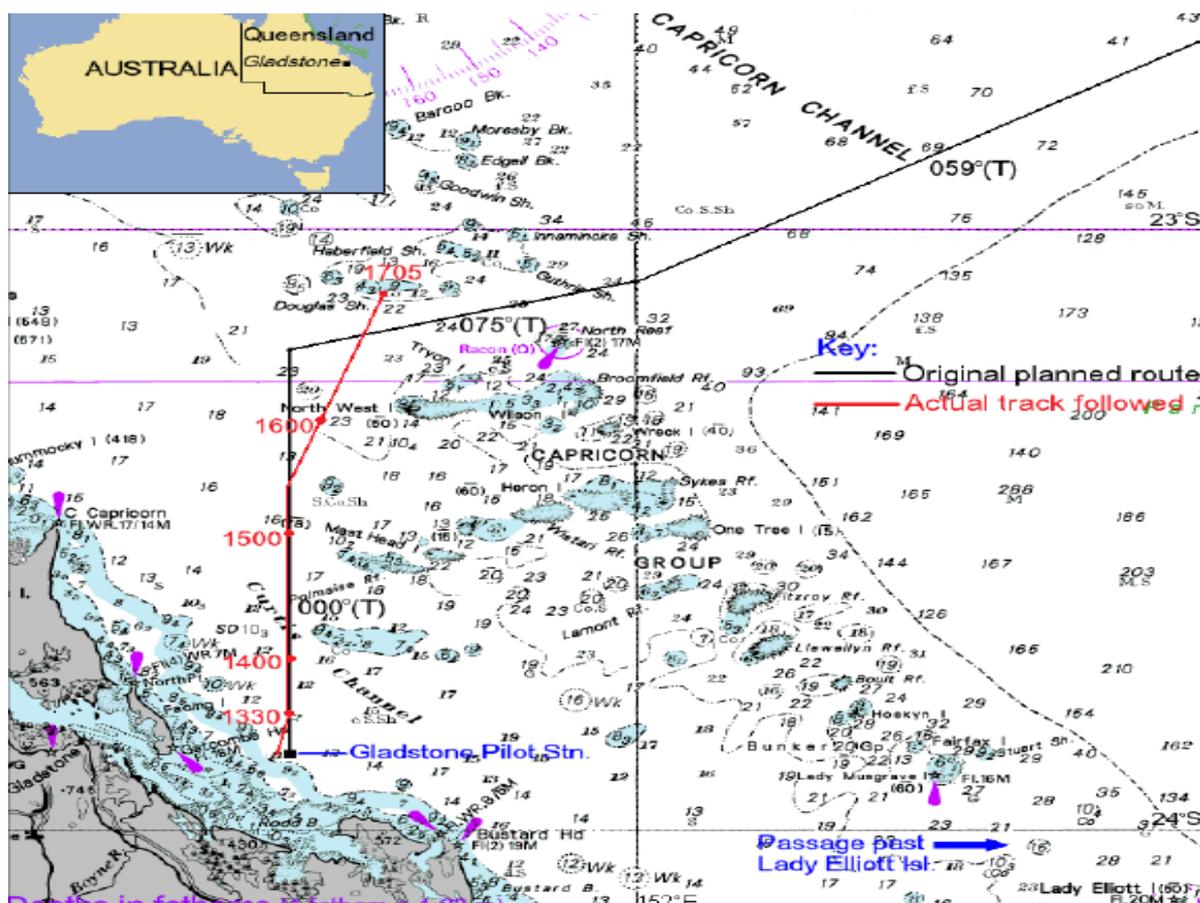
Figure 2: Chart Aus 426

Routes departing from Gladstone were determined principally by ships' destinations and draughts. Ships with draughts less than 12.2 meters intending to transit the Torres Strait usually follow the Queensland coast northwards along the Inner Route of the GBR. Different from other areas, pilotage is compulsory in the waterways north of Cairns; many other ships departing Gladstone exit the GBR near the port and then set a course towards their destinations. The GBR area off Gladstone can be safely navigated by using the general use zone and DSAs between the islands, reefs and shoals. This area has enough breadth and depth. The limits of the Great Barrier Reef

Marine Park and other Entry Prohibited Area are clearly marked on charts.

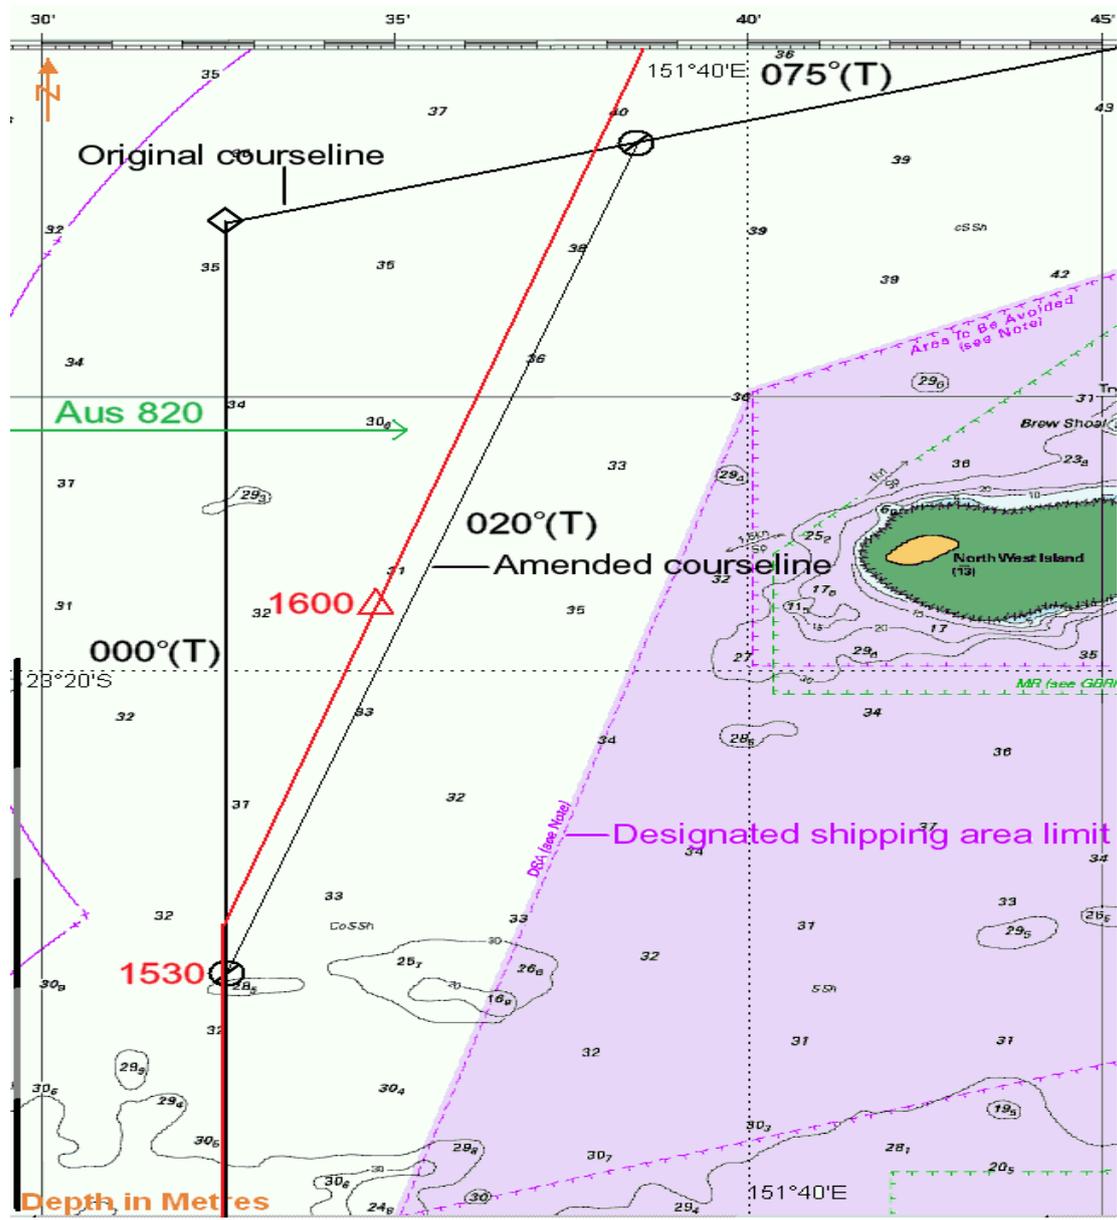
Shortly afterwards, the second mate suggested the master whether he could amend the track to economize voyage, and he explained his new plan to the master. With the master's permission, he laid a new course line of 020 on the chart, and the new track of 020 would be parallel to, and about 3 miles from, the DSA limit off North West Island.

At 1530, the second mate altered course to 020, but he didn't enter the new amended waypoints coordinates in GPS unit. Soon afterwards, the GPS cross track error (XTE) alarm sounded. The second mate cancelled the alarm manually.

APPENDIX A: Annotated section of navigational chart showing the original and amended route of *ShenNeng 1*

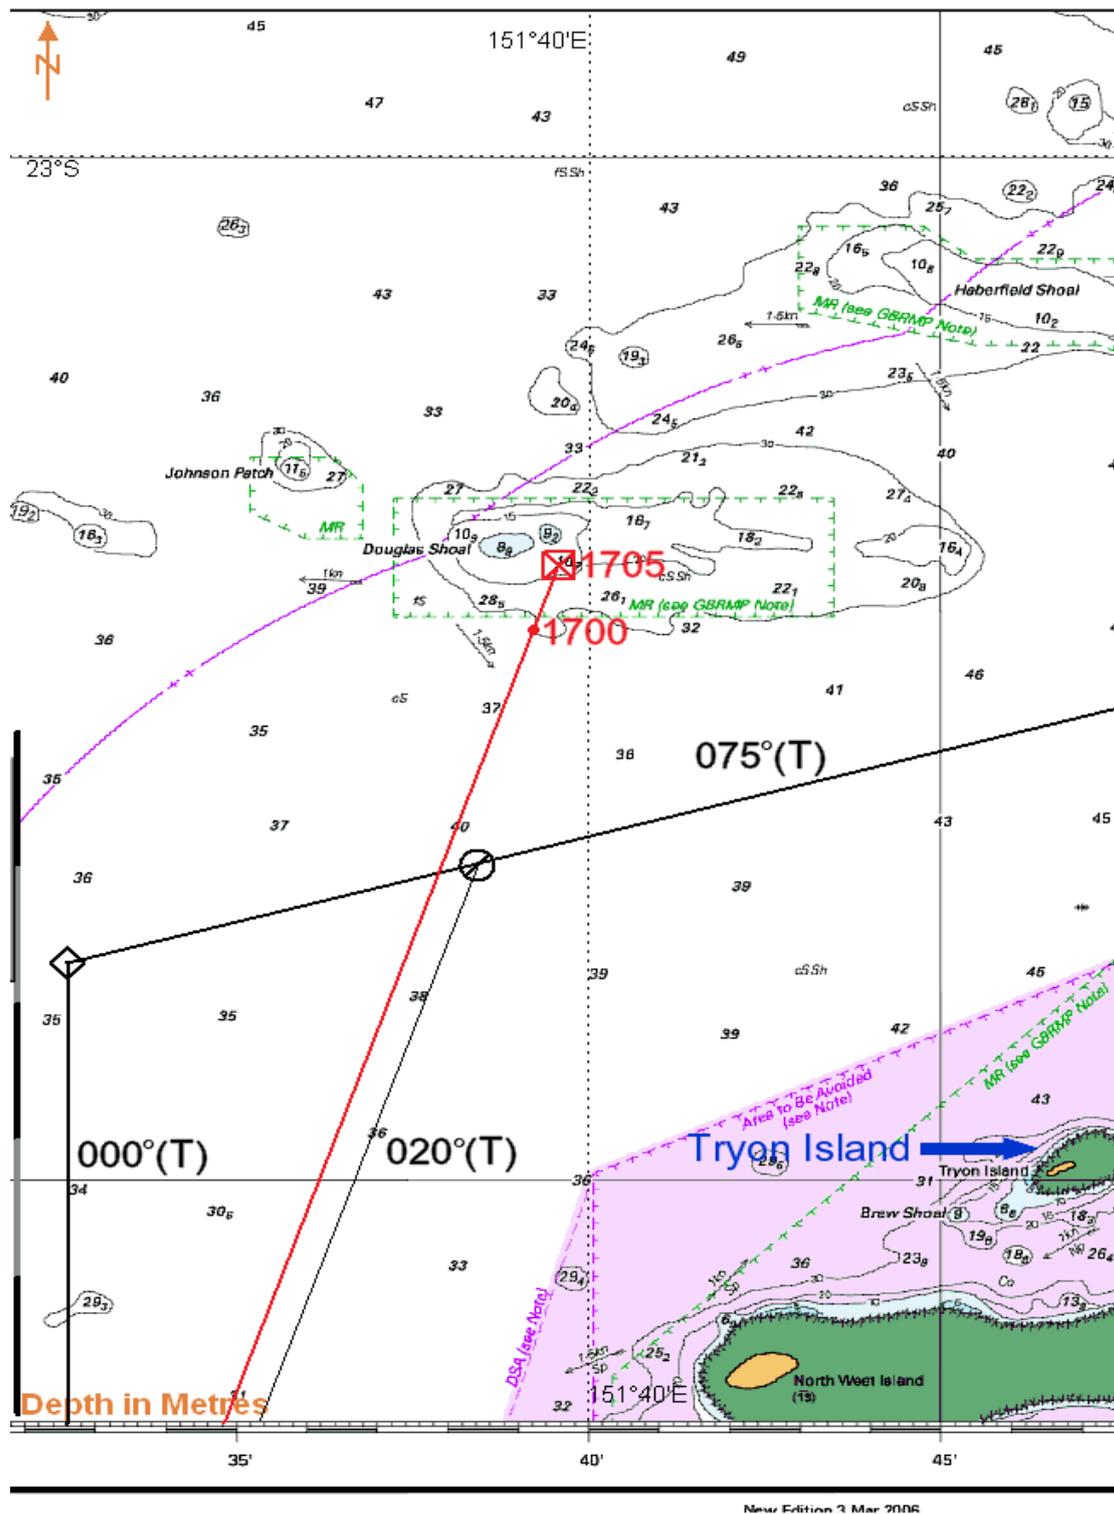
By 1705, *ShenNeng 1* grounded on Douglas Shoal with a heading of 020. GPS indicated the position was APPROX.23° 06'.0S/ 151° 39'.6E. It was read from the chart a depth of 10.7m where the seabed is composed of coarse sand, shells and coral. The Tide Table of Tryon island where was near to *ShenNeng 1*'s position indicated that it was 0.8m which was almost low tide at Douglas Shoal, and the next high tide would be 2.8m at 0002 on 4th April.

APPENDIX B: Annotated section of navigational chart showing the grounding position of *ShenNeng 1*
