**The Final Report on the Safety Investigation of
Air-conditioner Compressor Explosion on Board
Tanker Zhong Ran 53
off Jeju Island, Republic of Korea
21 May 2014**

Maritime Safety Administration of the People's Republic of China

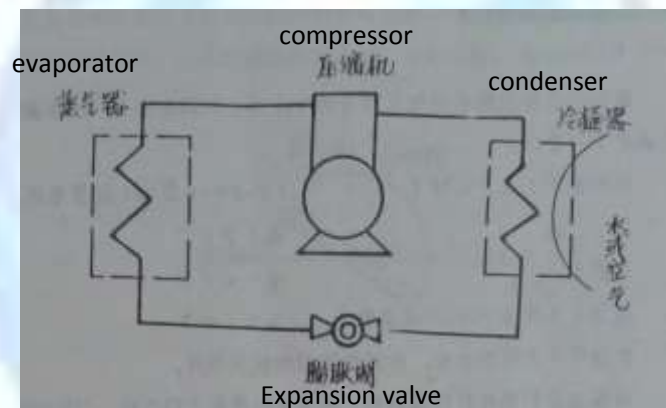
Figure 2: refrigeration system construction diagram

The ship air-conditioner refrigeration systems are single-stage compression refrigeration cycle system. The main components include compressor, condenser, thermostatic expansion valve, evaporator, forming a closed system with connecting pipelines. (See Figure 2)
