**The Final Report on the Safety Investigation of
Air-conditioner Compressor Explosion on Board
Tanker Zhong Ran 53
off Jeju Island, Republic of Korea
21 May 2014**

Maritime Safety Administration of the People's Republic of China

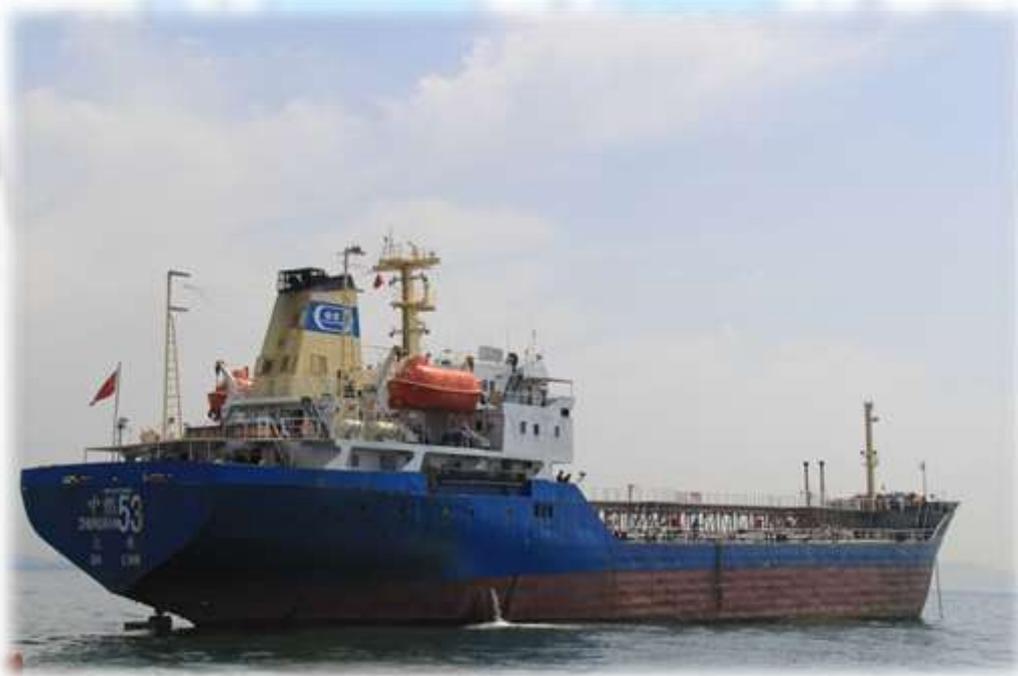
Figure 1.: Tanker Zhong Ran 53

At 2040 on 21 May 2014, the Chinese tanker Zhong Ran 53, owned by Zhongran Shipping (Dalian) co., Ltd., occurred an air-conditioner compressor explosion on board on her way from Zhangjiagang, China, to Yosu, Korea, in light ship at position (33°30' .57N/126°03' .68E) close to Jeju Island South Korea , 2 crews died as a result. This was a very serious casualty according to IMO Casualty Investigation Code.
